**ASPHALT REJUVENATOR**

**Pavement Preservation Technology**

Pavement Preservation Through Asphalt Rejuvenation

## RUNWAY FRICTION ANALYSIS Asphalt Pavement Rejuvenation Qualification

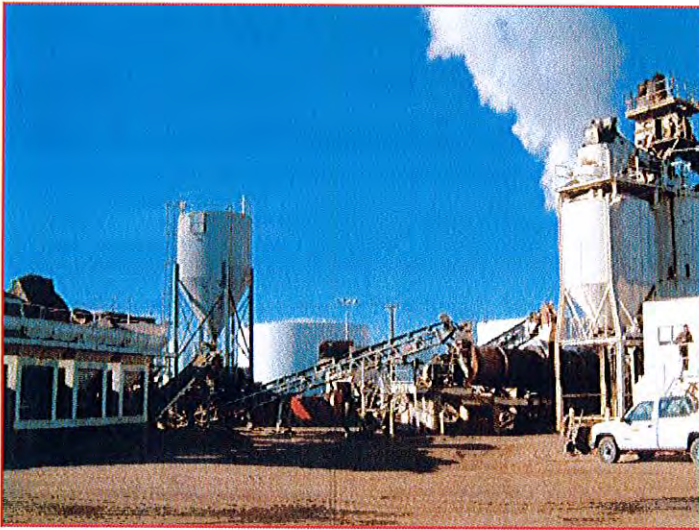
Asphalt binder is composed of organic molecules that react with oxygen. This reaction is called oxidation. Oxidation changes the molecular composition of the binder causing it to harden. Asphalt binder is composed of two petroleum fractions, asphaltenes and maltenes. This hardening is the conversion of maltenes to asphaltenes. Asphaltenes, the hard brittle component, serve as the bodying agent of the asphalt. It is insoluble and not affected by oxidation. Maltenes, the oily resinous component, is the balance of the mixture which is the glue that holds the mix together. Oxidation upsets the balance of Asphaltenes and Maltenes causing the binder to become stiff and lose its ability to hold the aggregate in place. **Simply, oxidation destroys the glue that holds the pavement together.**

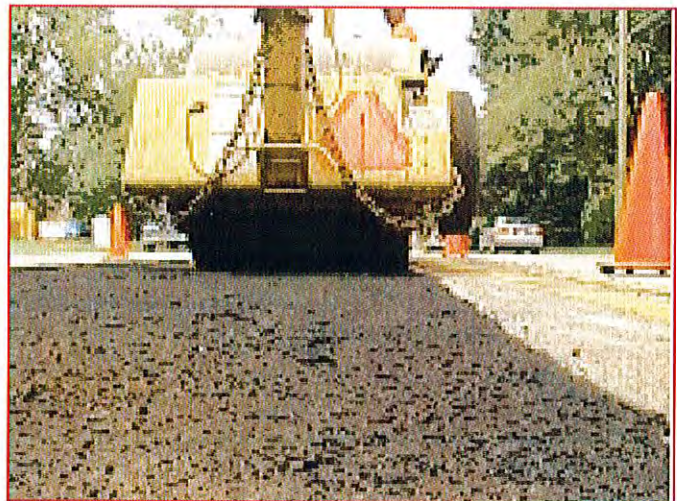
Oxidative hardening that occurs after the asphalt is placed is called Long Term Aging. It occurs slowly throughout the life of the pavement. The first visible sign of oxidative damage is when the color of the asphalt starts to lighten turning from black to gray. By the time the color of the asphalt is a very light gray or white, significant aging damage has occurred.

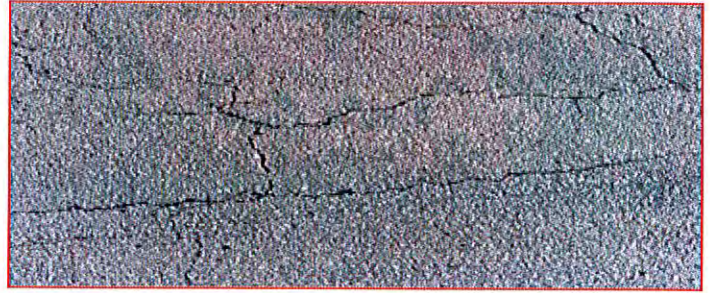
## Cracking

As the binder hardens, the top surface of the asphalt becomes brittle. When traffic pass over it and the lower levels flex, the top develops hairline cracks. This top down cracking is directly related to binder oxidation and signals an immediate need for rejuvenation.

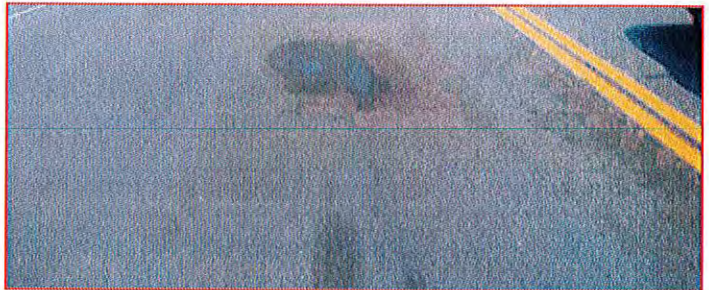
## Moisture Penetration

As the pavement ages, it becomes more susceptible to water damage. After a rain, the asphalt surfaces stay wet longer than the surrounding areas.

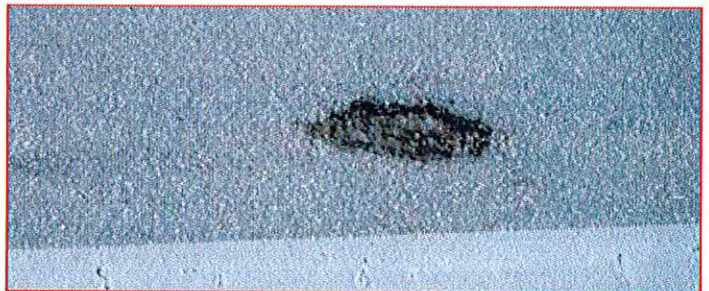
## Contaminant Degradation

Asphalt surfaces on roads and in parking lots are susceptible to damage from oil and gas leaked by parked cars. Airport ramps are damaged by aircraft refueling operations. These areas show up as dark spots that soon ravel, lose aggregate and become pot holes.

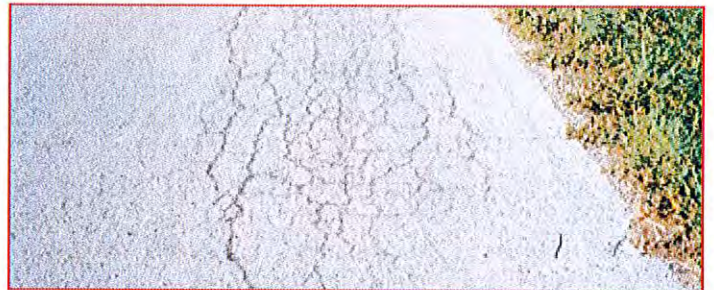
## Color Change

The color of the pavement changes from black to gray and then white. Sometimes it is difficult to distinguish asphalt from concrete at a distance.

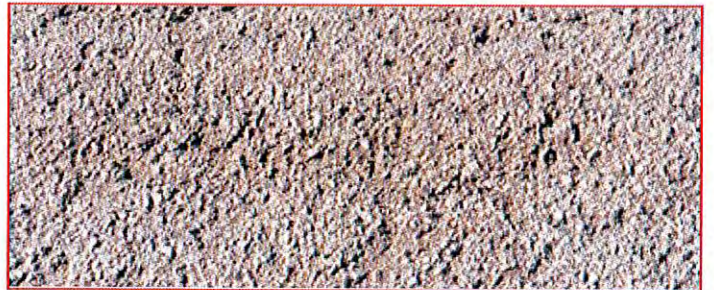
## Raveling Loss of Aggregate

Once the binder loses its glue like qualities, the pavement begins to ravel. Raveling is a loss of aggregate. This distress is evident in the last stages of the life of the pavement and rejuvenation should be planned immediately.

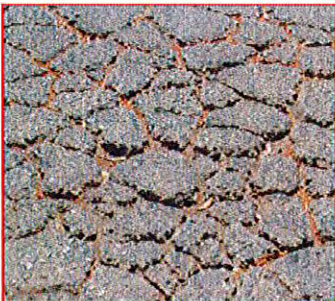
“Alligator Cracking” caused by seal coating.

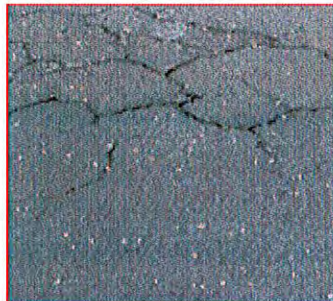
“Spider Web Cracking” caused by seal coating.

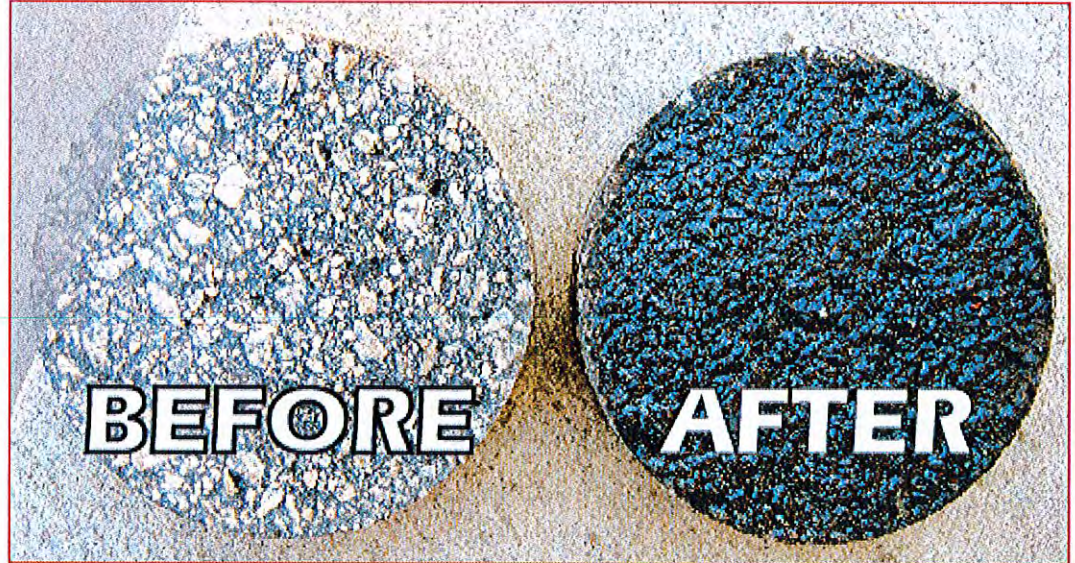
The core sample on the left was taken from an eight year old taxiway. It shows the effects of oxidation and aging. All of the original asphalt cement is worn off the stone and the binder has receded so there is stone loss. The sample on the right was treated with **Paverx** at a rate of 0.85 fl. oz. per square foot. It's original appearance is restored and the damaging effects of weather sealed out for many, many years.

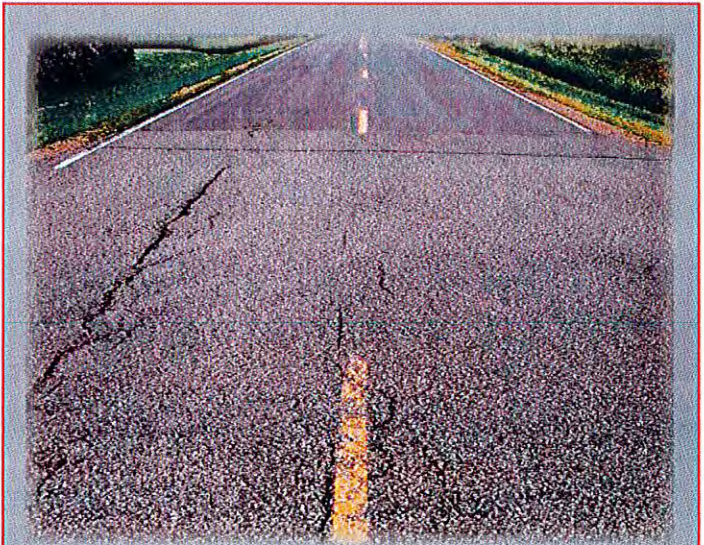
“These pictures were taken on June 1, 2010 and really do not do full justice to the dramatic differences in the road at this time. The one mile section of road that was treated with Paverx has additional cracking of approximately 1,000 lineal feet, while the remaining 6 miles has an additional 15 to 20 thousand lineal feet per mile. It proves that Paverx will extend the life of the asphalt roads”

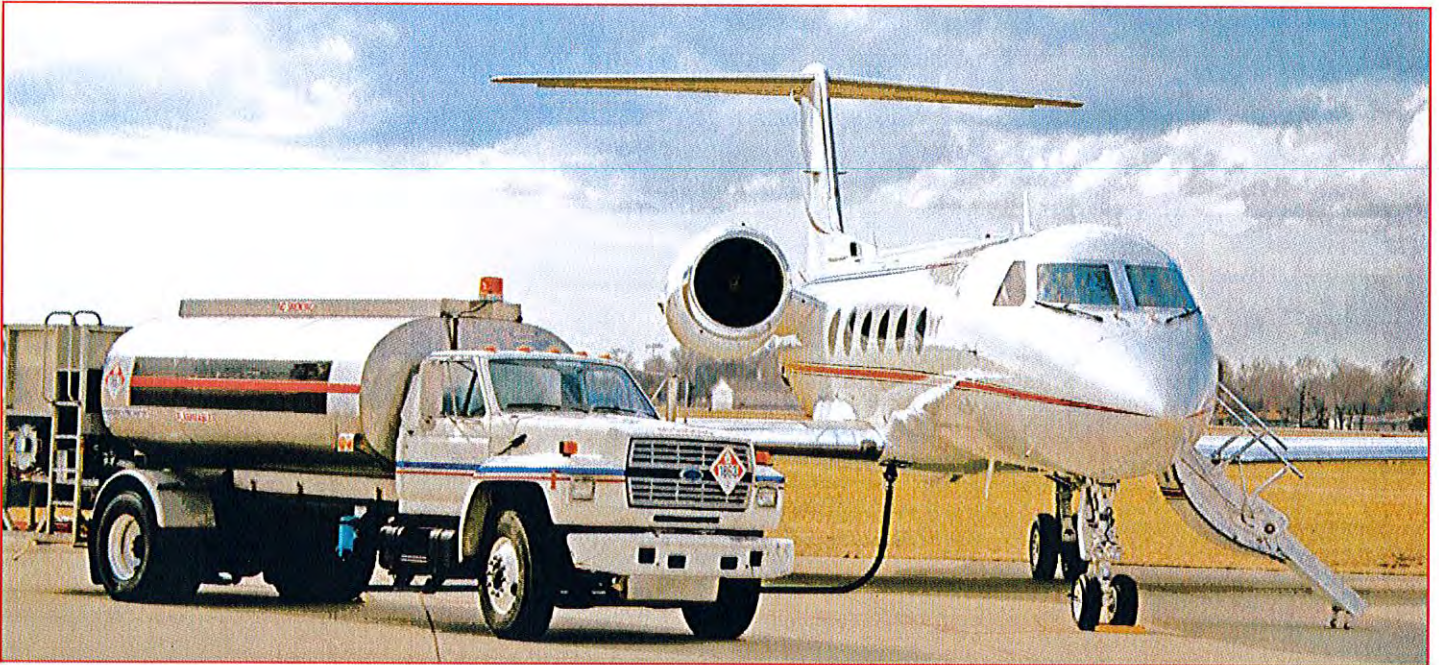
## **Paverx Prevents Damage Caused By Fuel**

Fuel leaked onto pavement breaks down the maltene component in asphalt causing an increased rate of deterioration. **Paverx** is fuel resistant. This means **Paverx** not only repairs damage to asphalt caused by fuel but seals and protects asphalt to prevent future damage.

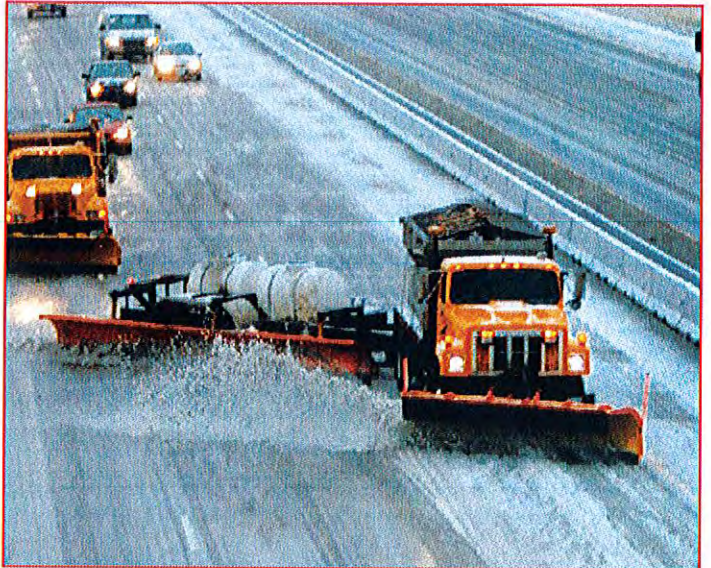
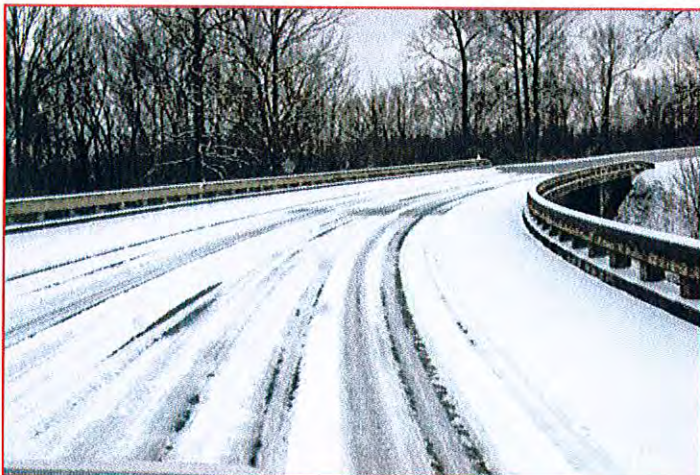
## Paverx Excels During Snow and Ice Season

Unlike traditional seal coats, **Paverx** makes pavement more resistant to damage by snowplows. Because slurry and chip seals only cover the top layer of asphalt and do not reach below the surface, their effectiveness as an asphalt revitalizer is destroyed during snow season. Snowplows scrape top layers of asphalt effectively removing any asphalt surface treatment along with snow and ice. **Paverx** penetrates into the deep layers of asphalt allowing it to maintain its effectiveness throughout snowplow season.

Although the primary purpose of **Paverx** is to restore, revitalize and reinforce asphalt, it also aids as an anti-icing agent. As part of the revitalization process, **Paverx** restores the traditional black color to asphalt allowing it to absorb more sunlight and thus slow the development of ice on roads and bridges. Denco Corp. in Iowa restores bridges with **Paverx** during the winter to restore color and prevent excessive icing.

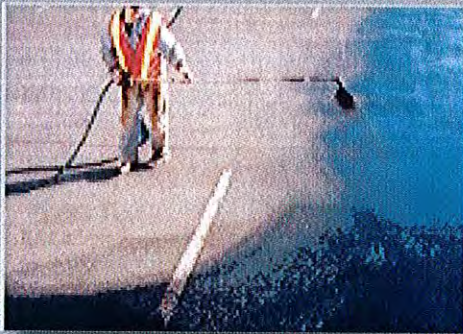
Traditional seal coats are typically applied using a sprayer system. While this does ensure complete coverage on top of the pavement, coverage is often uneven. It also further demonstrates the inability of traditional seal coats to penetrate the surface of the asphalt.

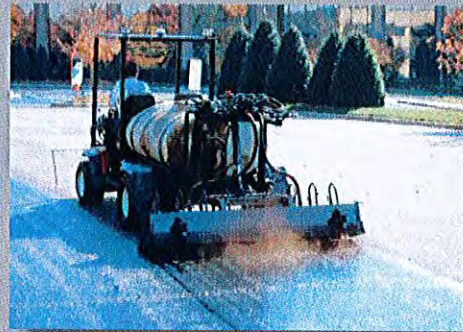
**Paverx** is applied with an asphalt distributor to ensure even and uniform coverage. By applying **Paverx** at a specified controlled rate directly to the asphalt, the chemical is able to permeate the pavement surface and deliver consistent results.
